## **Historic Preservation Commission Meeting SPECIAL**

**Proposed Railroad Safety Improvement Project--Montpelier STP 2950(2)**

Demolition of an existing structure (former church building) and full removal of foundation systems. Following demolition, the site will be graded, stabilized and improved for interim use as a non-paved parking and access area

## 144 Elm St Apartments LLC Structural Evaluation

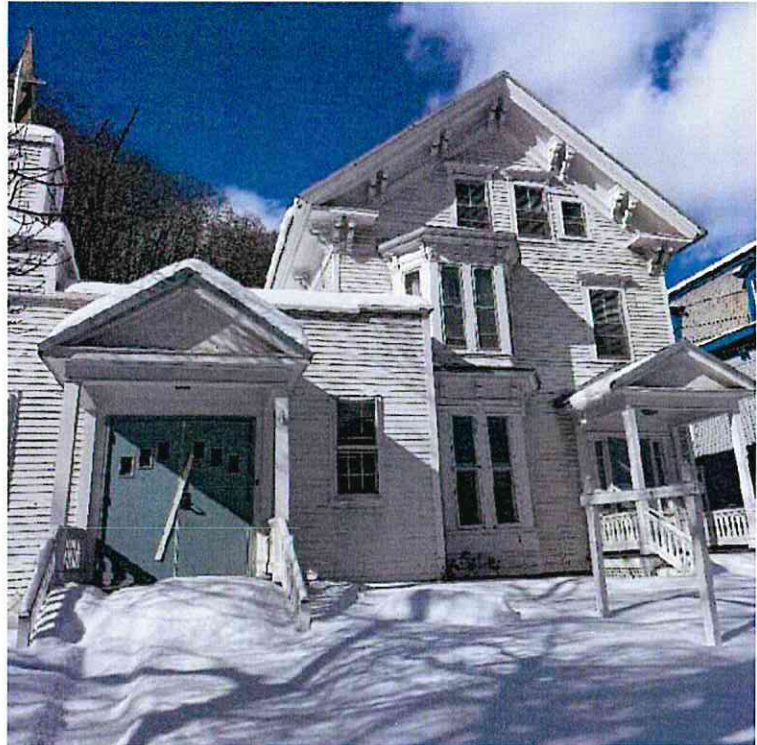
Front (south side) of the building taken from the sidewalk

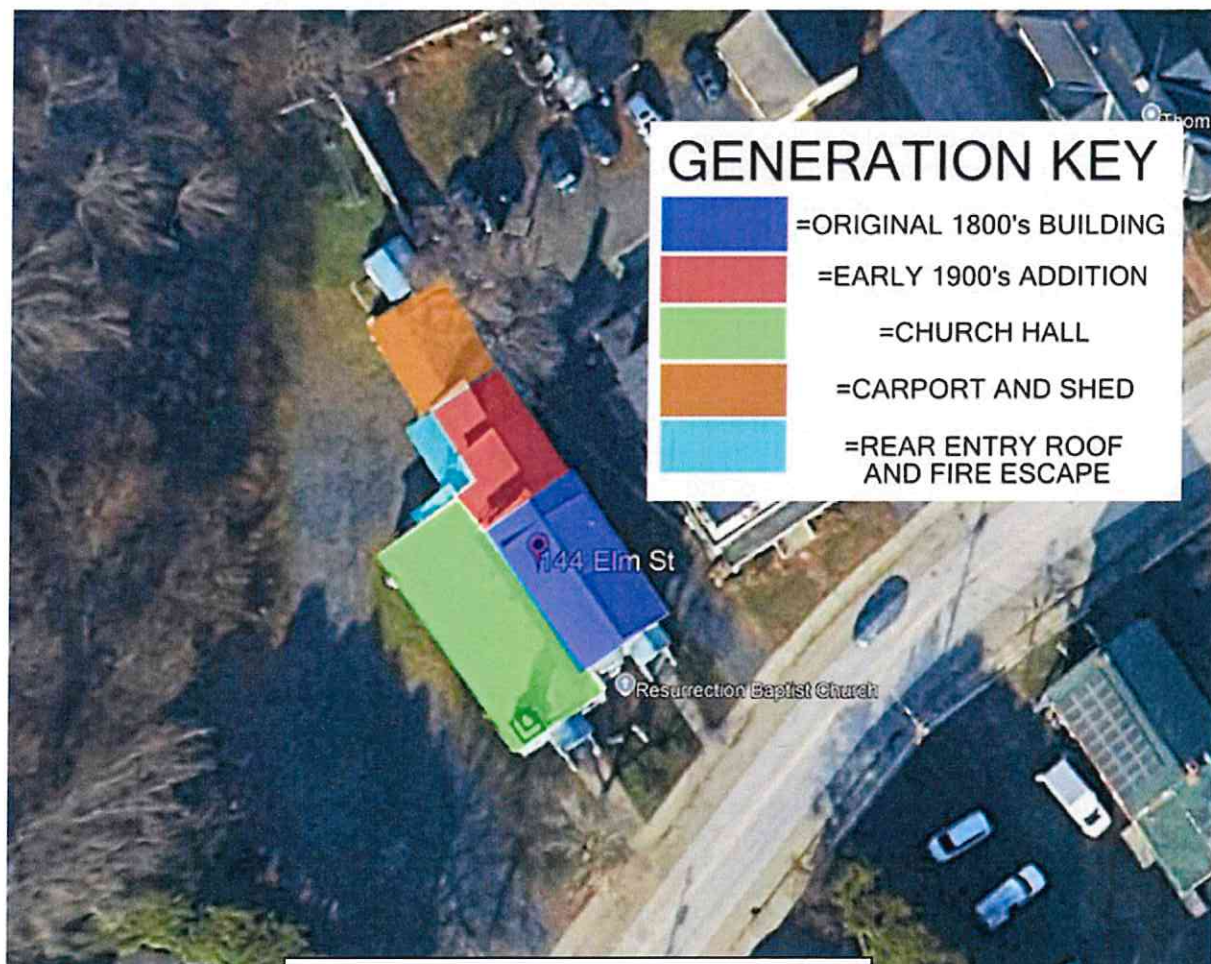
The structure consists of five effective generations of structures and additions. The original structure consists of the primary 3-story (historically residential) area of the building. This original structure is in the southeast corner of the property and generally has features suggestive of late 1800's construction. The next apparent generation is an addition on the north side of the historic structure and was likely constructed in the early 1900's. This addition is 2 stories with a partially finished attic space. It is unclear if this portion was built at one time or in separate portions. Due to similar age and conditions, this report will refer to it as a single addition. The third-generation addition consists of the western church gathering hall which was likely a partial renovation to a historic addition. This addition appears to have been renovated in the late 1900's or sooner but older features are still visible in the floor framing. The fourth addition added to the building is a carport and shed added on the rear of the building. This space is constructed likely in the late 1900's and is unconditioned. The fifth addition consists of the exterior 3<sup>rd</sup> floor fire escape stair and the rear entry roof (assumed similar age solely on condition and framing practices). Other renovations and adjustments have been made to these spaces but for this report, the layout will be based on these 5 primary generations/additions.

Report generation key (*Print in color*)

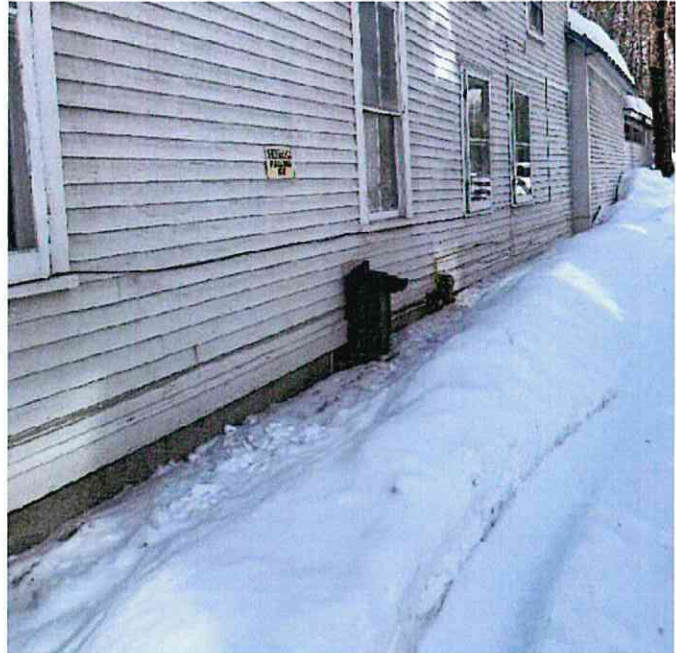
The site also is prone to surface water degradation and frost activity due to negative drainage on several sides of the building and maintained (salted and plowed) driveway/parking a large percentage of the perimeter.

Negative drainage example on east side

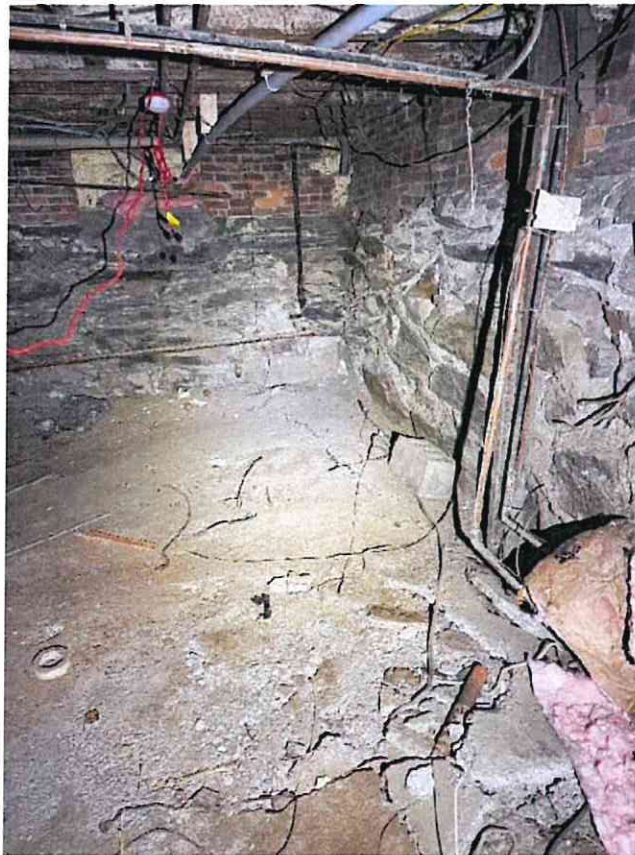
This basement consists of field stone foundations changing to brick masonry at or close to grade. Outside this brick is a large stone block (likely a granite). The basement has several interior stone foundations, some of which have been historically replaced with cast in place concrete piers (footing sizes unknown). A thin, unreinforced ("rat") slab had been poured in the space. This slab shows significant signs of frost and flood damage. The slab has been lifted between 1 and 2 feet in some areas causing cracking, and voids which make an unstable walking surface. The stone walls are also showing signs of significant movement with interior bowing, cracking and global leaning.

A corner of the original basement with frost activity moving the slab and walls

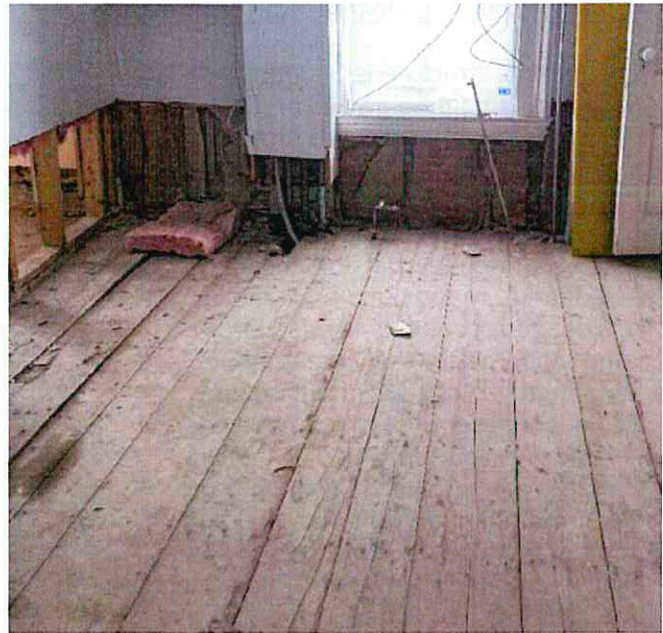
First floor lifting at the interior wall  
(see left of photo)

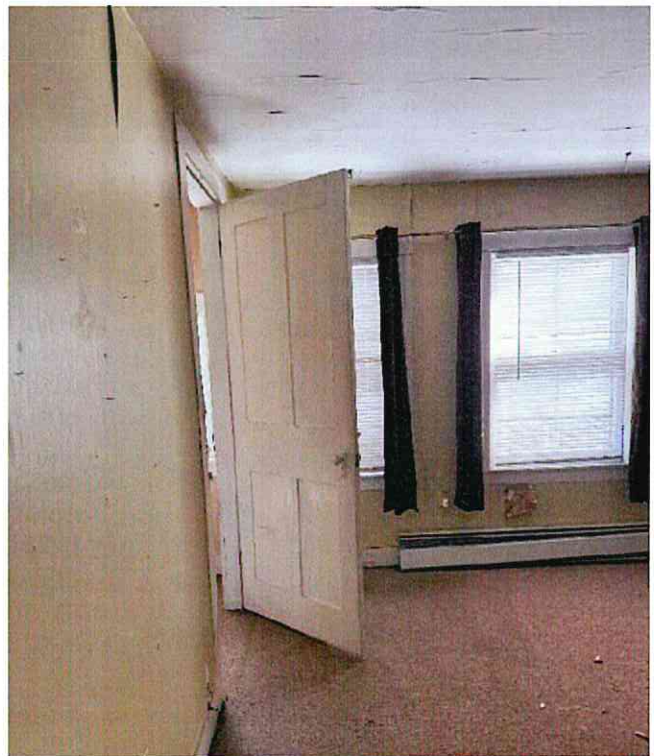
The third floor is generally the same condition as the second-floor framing and walls. A similar interior floor slope can be observed. A window on the front of the building had been left open which is generally beneficial for matching interior and exterior temperature swings and managing moisture, but it has resulted in increased localized water infiltration due to rain and snow entering through the window. The roof framing is concealed in all locations and is framed as a gable roof with a large dormer and high collar tie. No significant ridge settlements are observable but minor settlements appear historic and are expected due to the age of the structure.

Third floor settling toward interior wall, interior finishes suggest long term high humidity

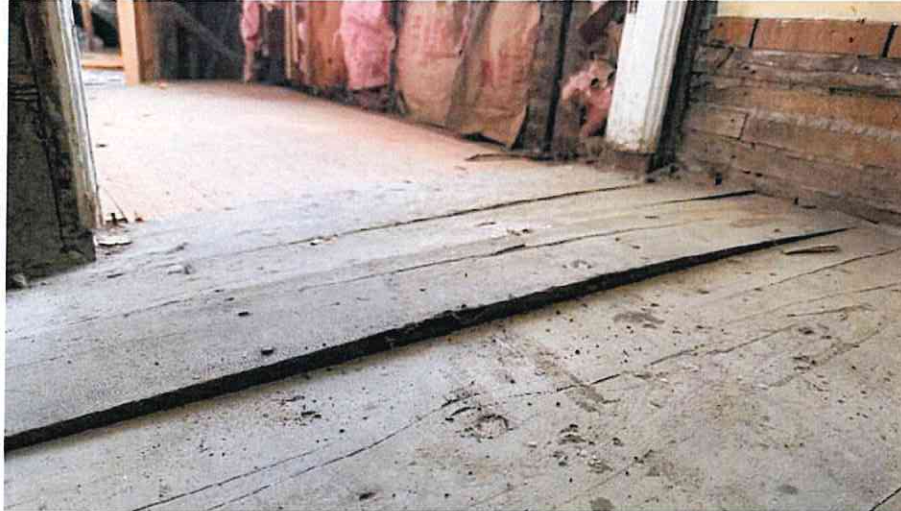
This portion of the structure is framed with rough sawn lumber, but the foundation consists of a short "framing on dirt" crawlspace with shallow foundations. This has resulted in significant movement to the foundations now that the building has been left unheated. The largest area of this is where a supporting foundation has lifted enough to cause it to break through the first floor, ultimately cracking the plank decking. Frost heaving has lifted several of the floor joists in this first floor. The second floor is limited to one room with sloped ceilings and a high collar tie. Finishes conceal the framing, but a general (though less exaggerated) floor movement is observable.

First floor of addition having localized deflections due to foundations below lifting through floor framing

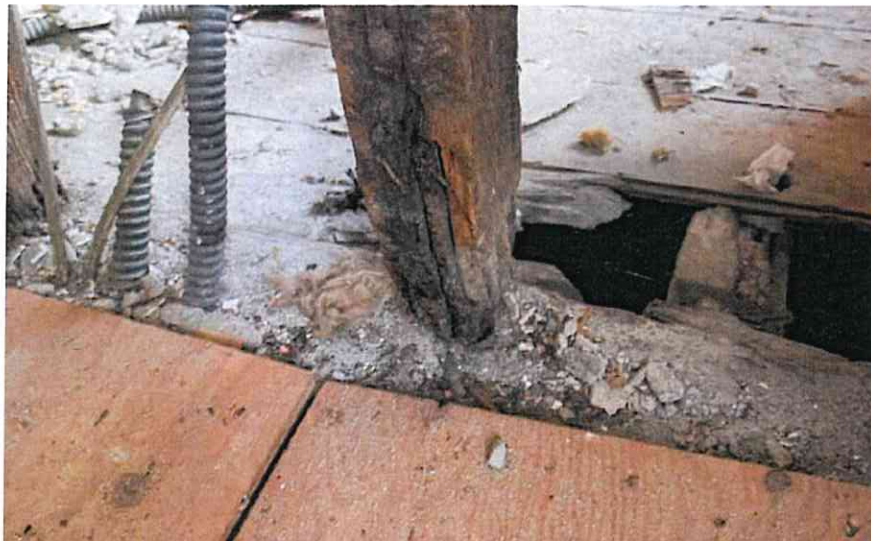
Example of column in addition experiencing significant section loss due to rot/deterioration

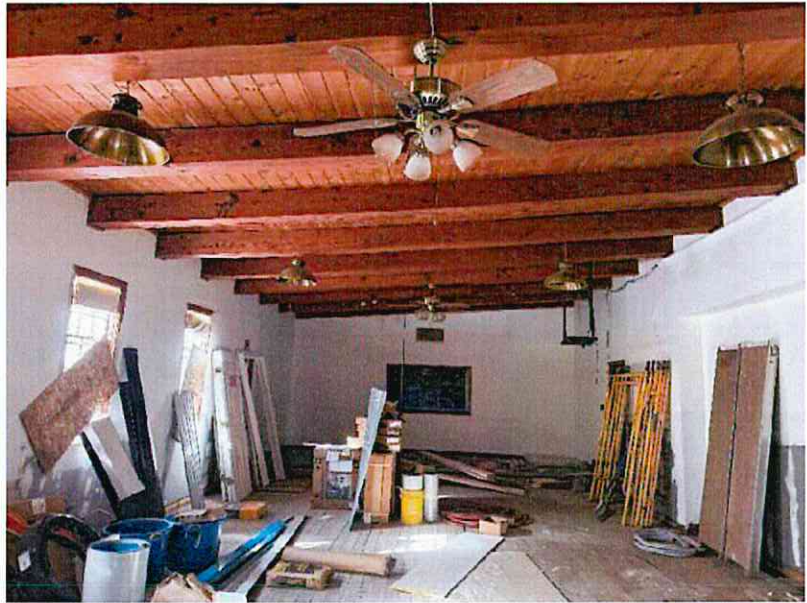
Wall framing is visible through removed finishes in the southern end of the building suggests the walls are at least partially framed with dimensioned kiln dried lumber. The northern end, however, behind the "baptism tub" shows a rough sawn and plank sheathed exterior wall. This northern wall has significant signs of condensation. At the time of visit the wall was covered in a layer of frost.

Church hall, recent renovations started, framing mostly concealed

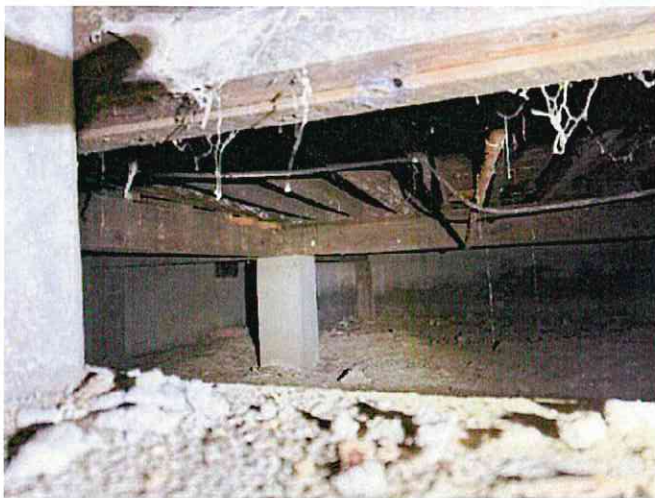
Crawlspace below church hall showing newer foundations with older rough sawn floor framing and plank sheathing

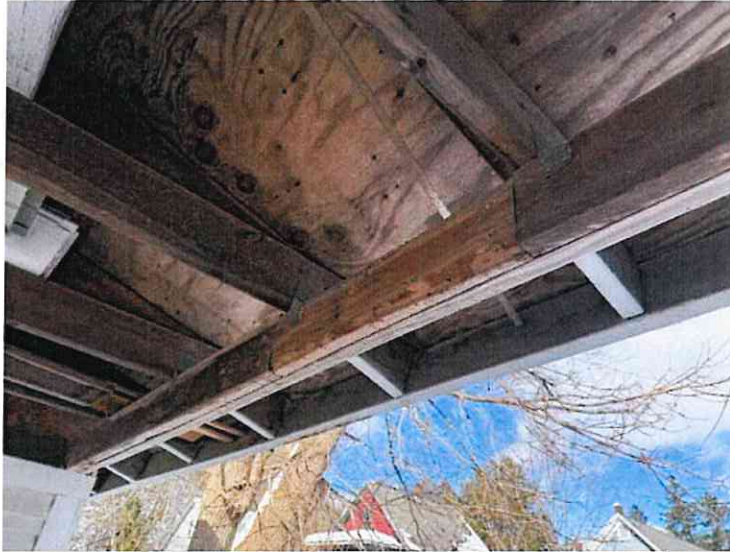
The carport and shed are framed with dimensional lumber. The rafters are tied with collar ties on each rafter. The collar ties bear on two ply dropped beams. These dropped beams are visually deflecting. The deflection appears to be partially attributed to moving columns and partially due to the beam being undersized. The columns are bearing on the slab. The slab is heaving due to frost movement. In at least one location the column broke through the slab as the slab lifted.

Improper beam ply splice at carport

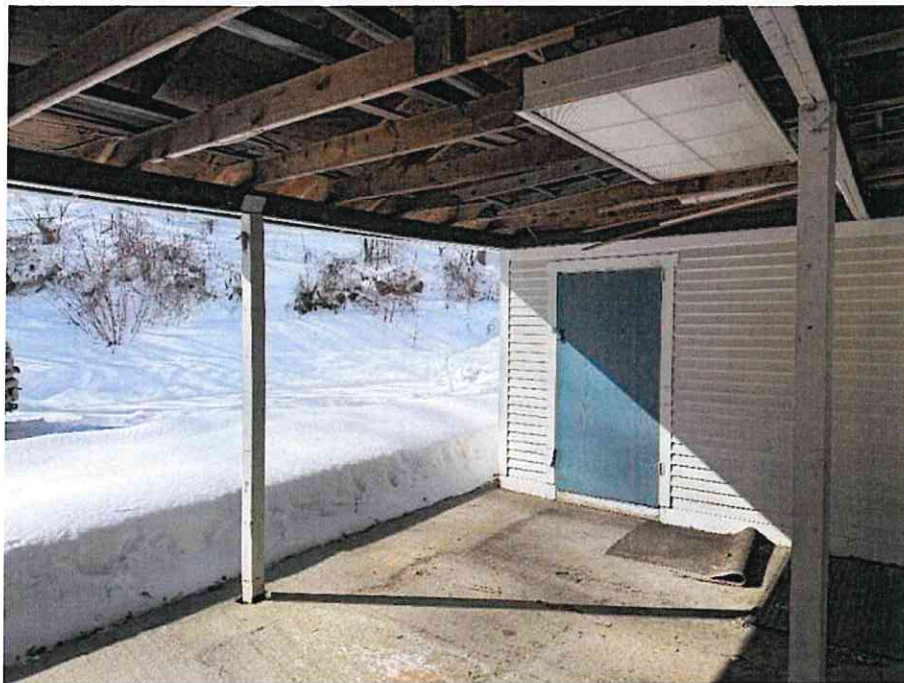
Beam with observable deflections and column settling away from slab

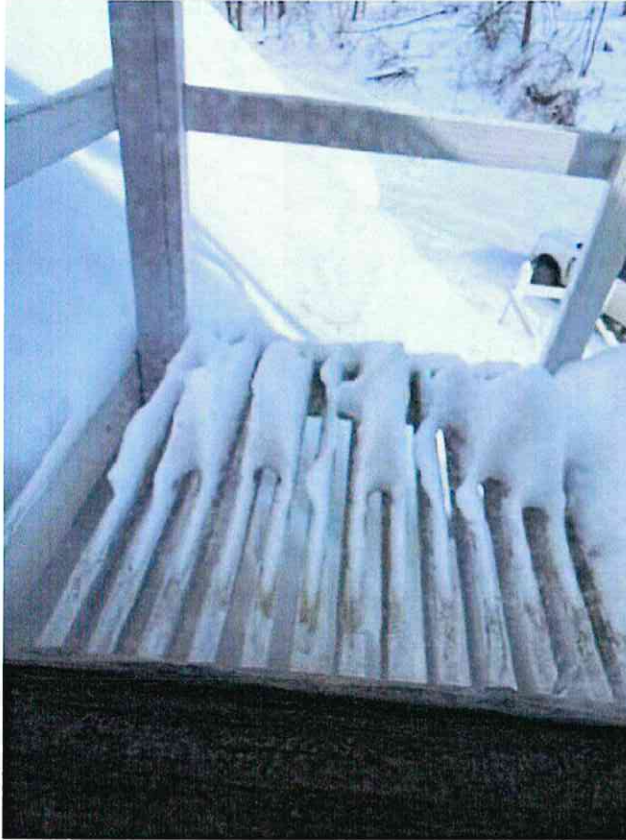
The stairs are located at the back (north) of the building and bear directly on the earth below. No foundations are observable. The stairs are nearing the end of their design life and show signs of rot and connection failure.

Top landing of fire escape stair with rot and unconventional dense framing without decking

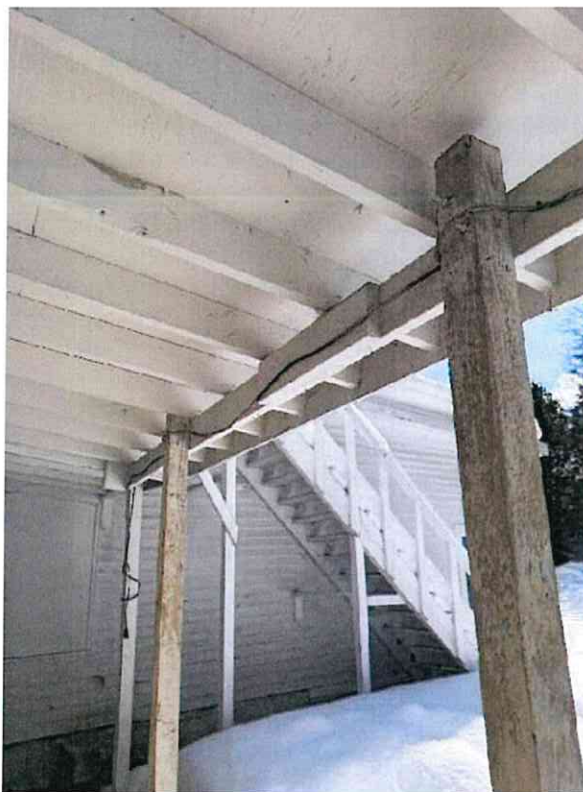
Entry roof rafters bearing on a single ply (improperly spliced) beam, columns bolted, not bearing

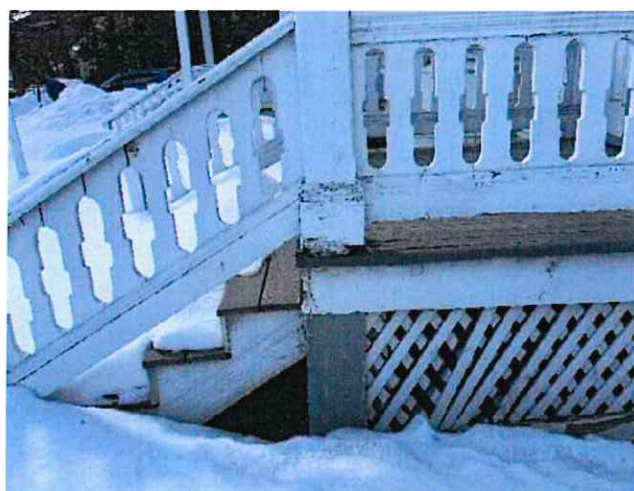
On the front of the building the church hall addition as well as the original structure portion have similar front porches. The porches are of different ages with the addition porch being newer construction. Decking on both appear to be nearing the end of their design life. Joists below were generally concealed due to high snowbanks and finishes. Both porches are experiencing some movement and pulling away of their stairs. At the addition the porch appears generally stable and is constructed on pipe columns with unknown footings below. The porch at the original portion is experiencing significant frost movement due to inadequate foundation depth.

Eastern porch at original building settling at foundations

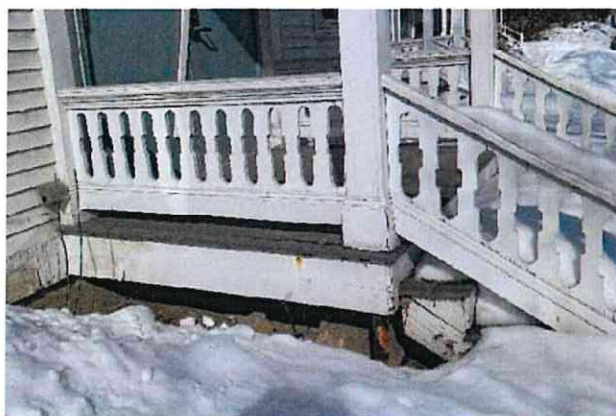
Stair at church hall porch dropping away from porch

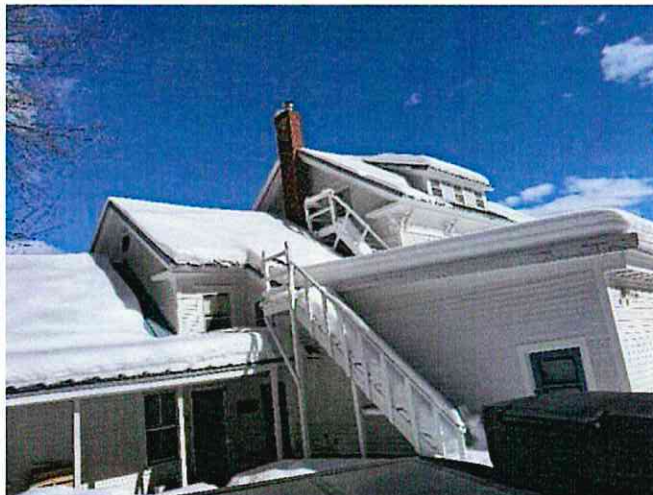
Building from exterior, Northwest corner
